Modification; register rings for VSOP

DgpS can supply a modification kit to solve the issue of broken register pins for sleeve positioning.

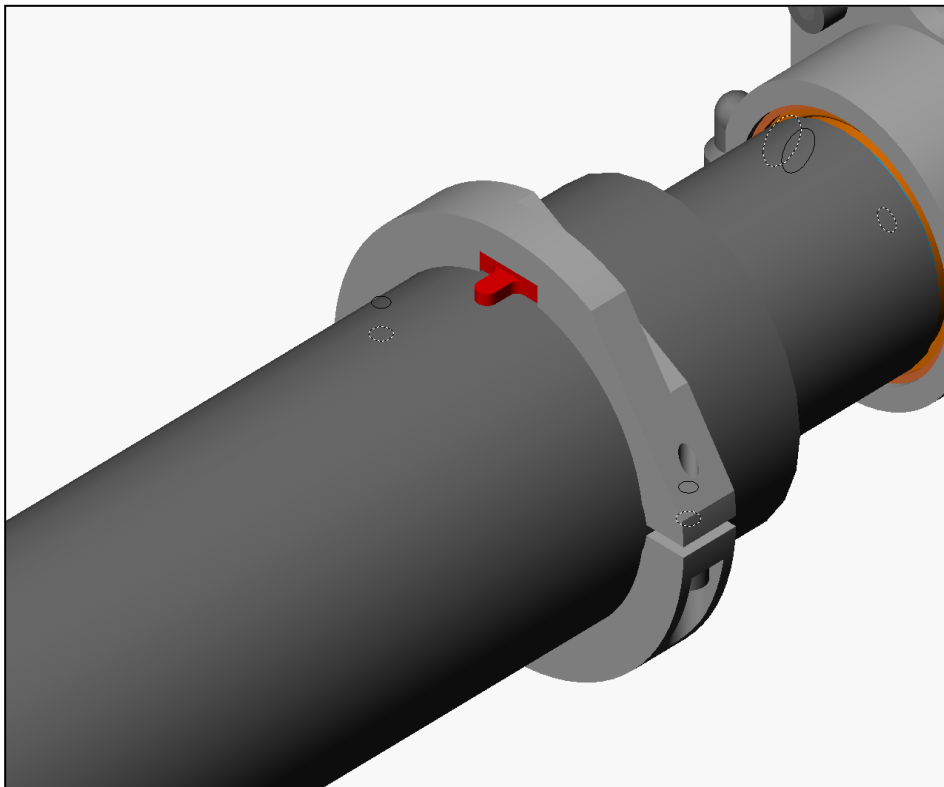
The increased weight of the new generation sleeves leads to an increased load on the register pins on the sleeve mandrell.

The existing pins on the Drent VSOP presses can damage. Repair of broken register pins is time consuming and will require special skills.

By mounting of a special designed register ring and register plates the system is more robust. Eventual replacement of broken plates is easy, quick and can be done without special skills.
